THE SINKING OF A SHIP

COSTA CONCORDIA REVISITED.

Captain Michael Lloyd, RD**, MNM, CMMar, FNI.

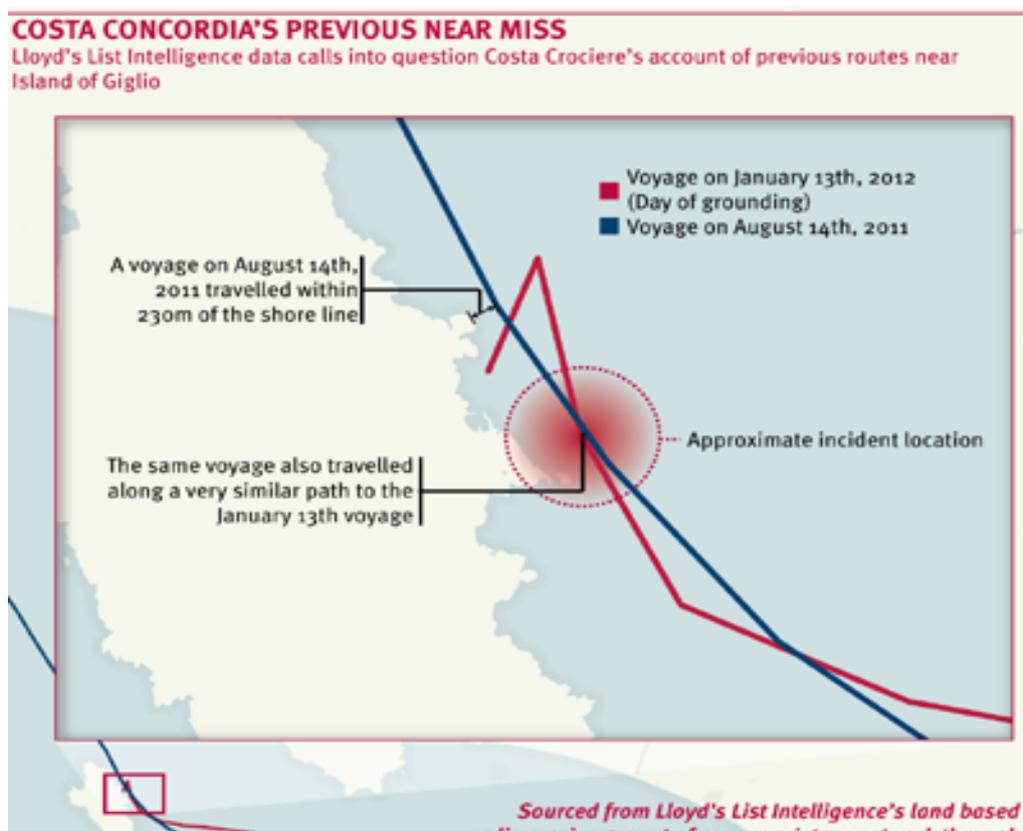
Despite the Company's denials, On August the 14th 2011, with authority to do so, the ship under the same Captain made an almost identical pass by the island. The only difference being the angle of approach to the island as the diagram below shows.

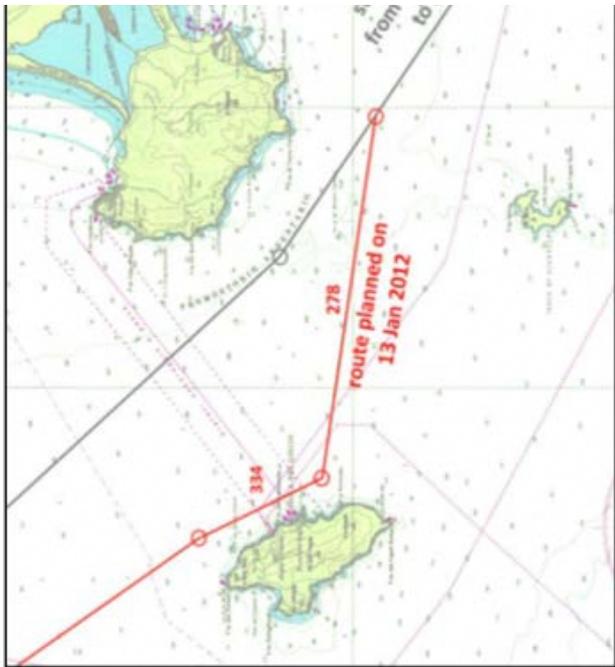
On 13 January 2012, only the original route was drawn on a paper chart (with a scale of 1:100,000). The chart was used to plan the deviation, but it was not actually plotted on the chart. Instead, the planned deviation was uploaded to the ship's automated navigation system (the Integrated Navigation System (INS)), which, according to international law, could only be used as an aid to navigation when sailing close to land; not the primary means.

The deviation ordered by Captain Schettino.

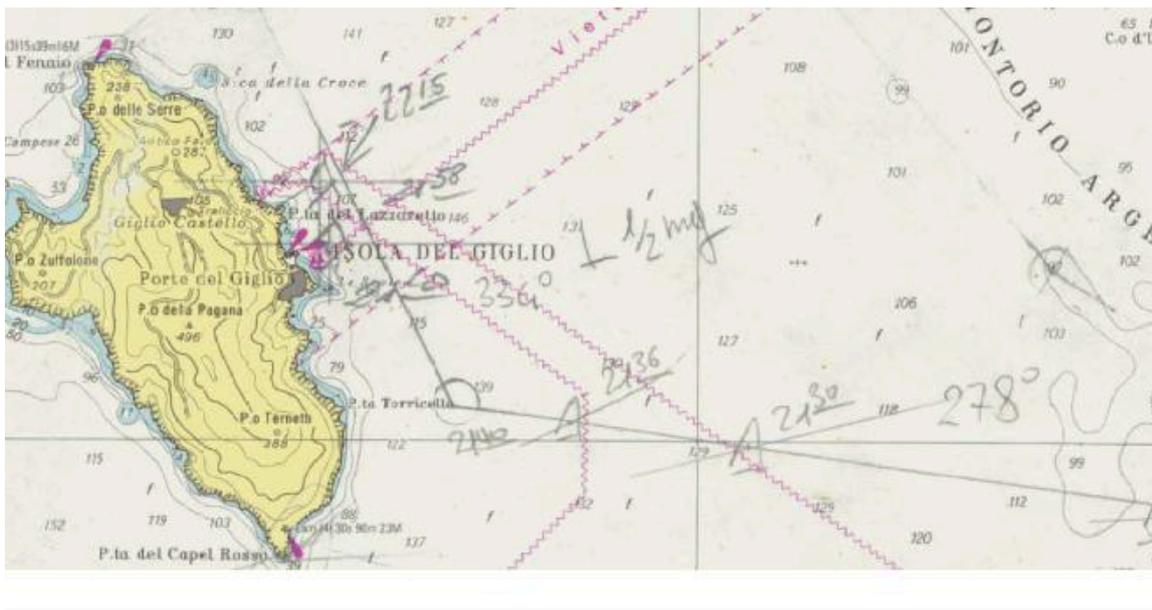
Excerpt of the navigation chart in use on the bridge. The scale on this chart is 1: 100,000 Instead of the correct chart 119 scale 1:20,000. The second officer, as the ships navigation officer, would be responsible to the Captain for the correct charts being available.

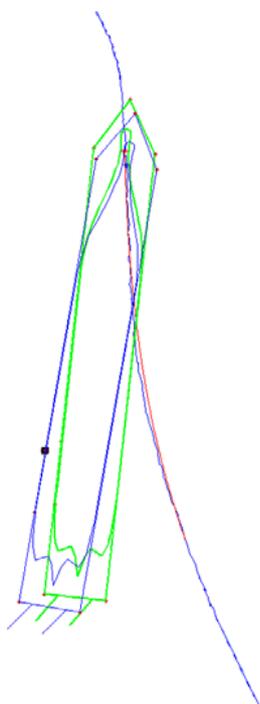
In the figure below, the blue outline represents the actual ship position at impact time while the green outline represents the simulated ship position, without the helmsman's error. The black ellipse represents the rock's position. As can be seen, in this case the left bulkhead of the ships is about 10m from the rock. One could safely state that, according to the simulator, the ship would have passed close to the rock without impacting or, considering the worst case for the simulation error and model approximations, the impact could have occurred about 18m behind.

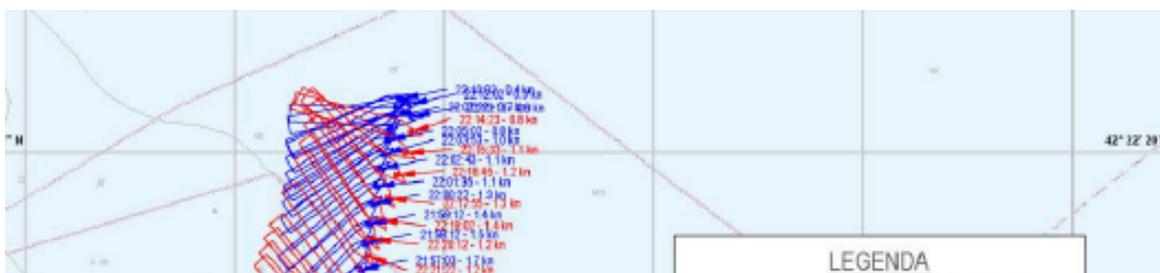
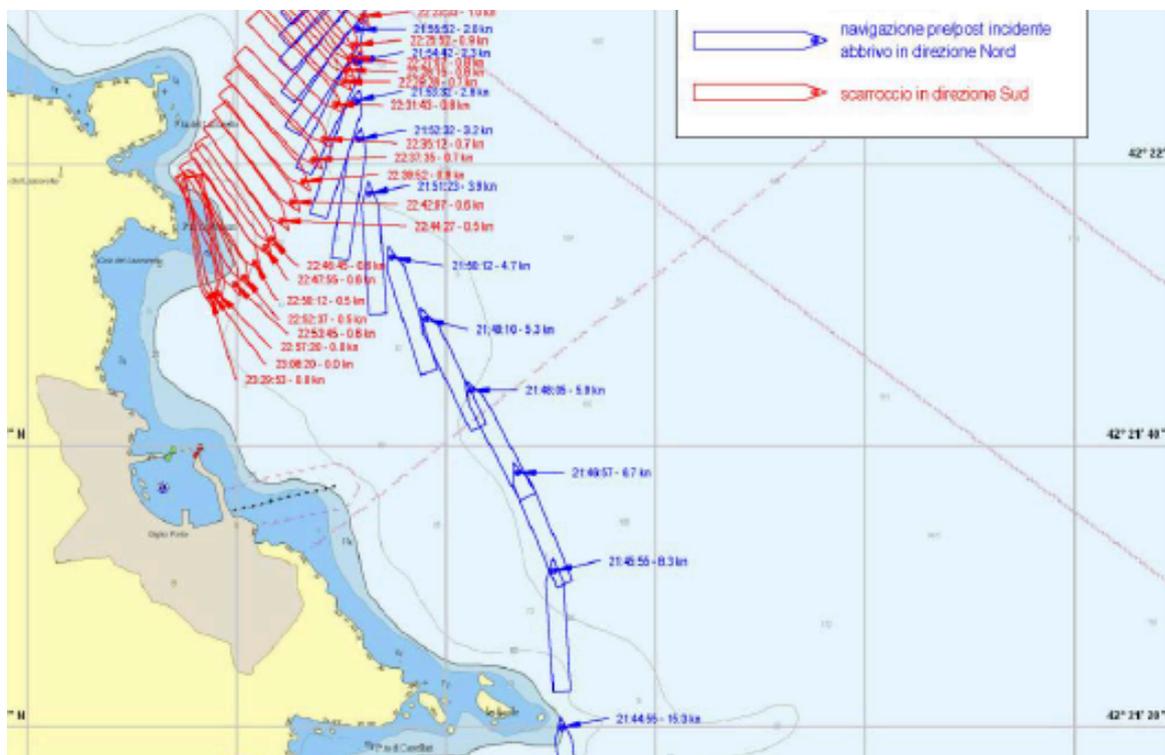
Track of the ship after the grounding. The Blue track is the ships continuing course. to the North. As the momentum of the course and speed following the collision gradually ceases, the effects of current and wind gradually control the ship and she drifts South West as shown in red.

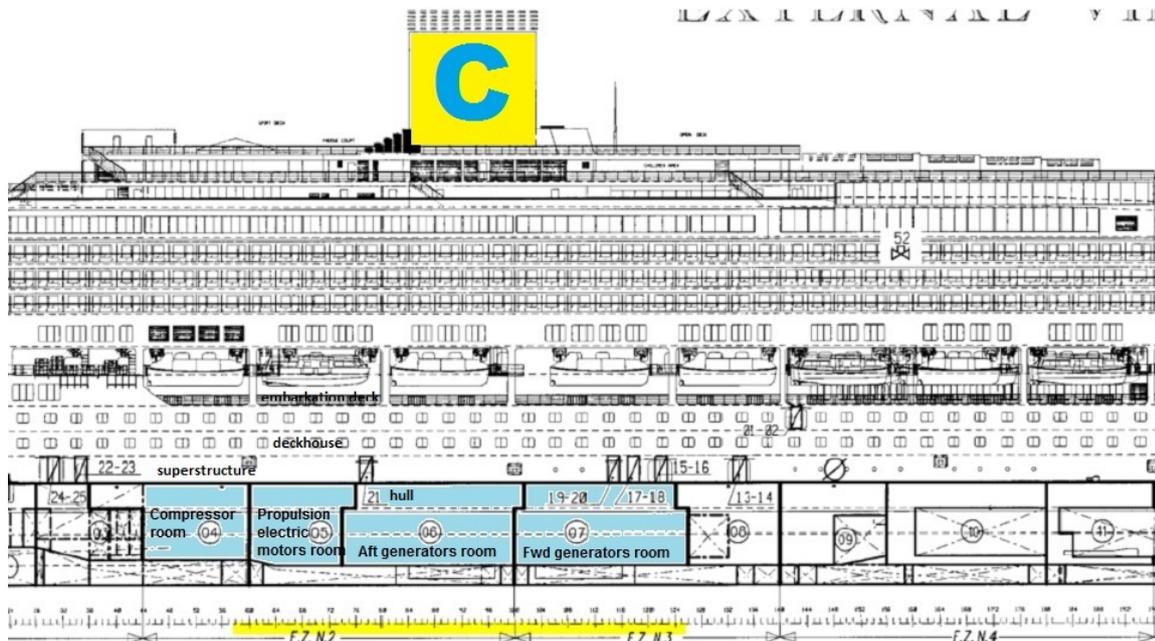
The flooded compartments contained a number of critical systems such as main diesel generators, ballast and bilge pumps, electrical propulsion motors. The flooding of these compartments resulted in black out of main electrical network, loss of propulsion and various high capacity sea-water service pumps. 6 compartments flooded within 40 minutes.
