THE SINKING OF A SHIP

COSTA CONCORDIA REVISITED.

Captain Michael Lloyd, RD**, MNM, CMMar, FNI.

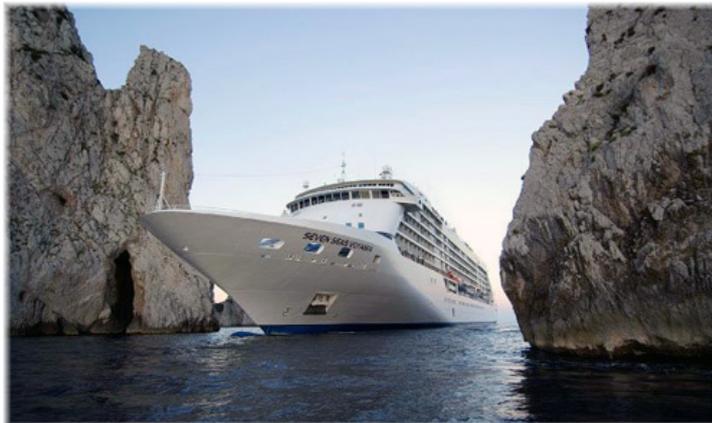
cruise ship Seven Seas Voyager of the American company RSSC. "bowing" to the Faraglioni rocks off the island of Capri.

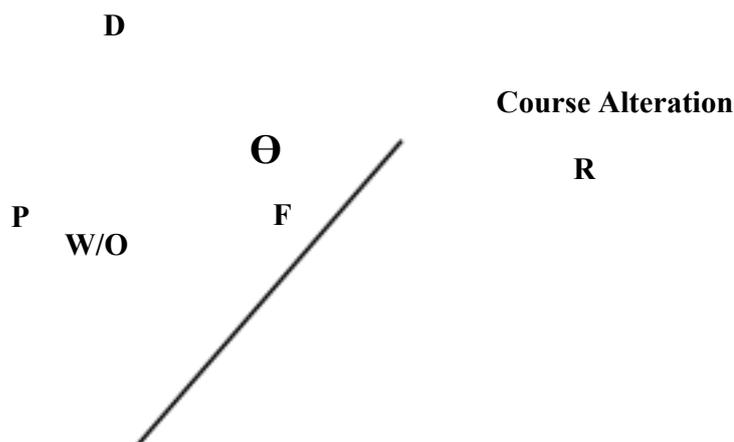
Factors of a Wheel Over.

Wheel over positions can be found from the ship's manoeuvring data. These are of special importance when making passage in rivers or channels. Most ships have ready for use pre calculated distances based on speed, degree of helm required, degree of turn and draft. F = Head Reach – Distance travelled by vessel after giving wheel over & before commencing turn, i.e. distance to overcome inertia.

P = Perpendicular distance from wheel over point to new course extension.
